4U Home, Inc

Sewer Inspection Report

Property address: Some Where Dr

Inspection date: Wednesday, July 22, 2020

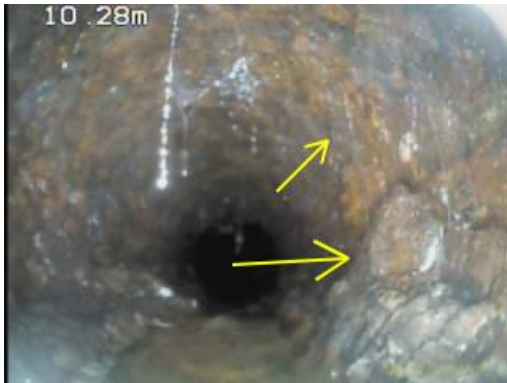
Photo 2-1

Heavy rust / scale was visible at the cast iron portion of the main sewer line This could be caused by age and material of pipe. Recommend that the main sewer line be cleaned / hydro-jetted and re-inspected with a camera before the inspection objection deadline.

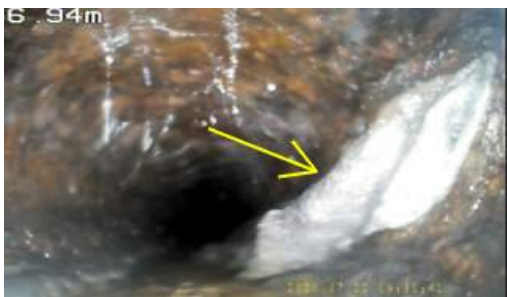
Construction debris / foreign objects. This could be caused by items that do not dissolve or break apart in water. Recommend that the main sewer line be cleaned / hydro-jetted in the future.

Photo 3-1 looks like a rag or towel of some sort. Recommend Cleaning line

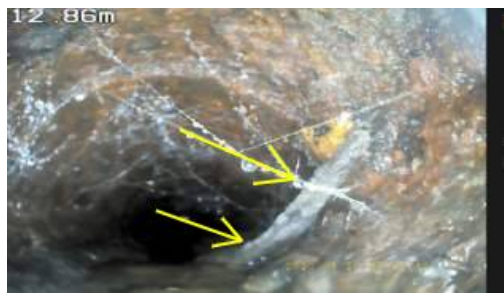
Photo 3-2 looks like a rag or towel of some sort. Recommend Cleaning Line

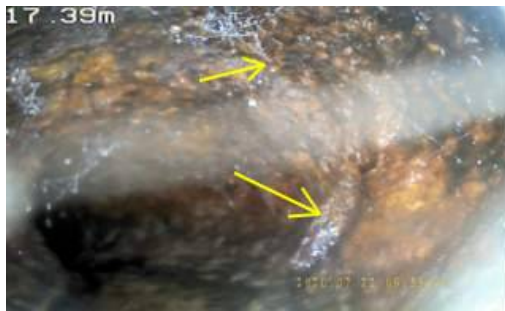
Photo 4-1

Joint offsets / broken joints. This could be caused by shifting or settling of the soil surrounding the pipe. Does not appear to be causing any flow issues at this time. However, recommend periodic review.

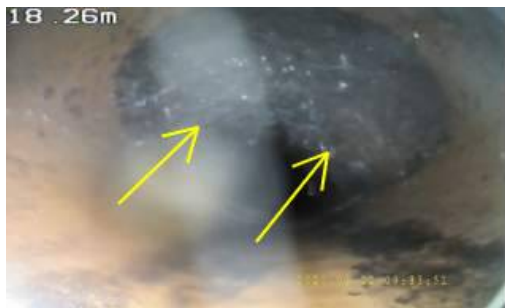
Photo 5-1

Minor Root Intrusion. This could be caused by near by tree or bush. Does not appear to be interfering with flow in drain line at this time. However, recommend periodic review.

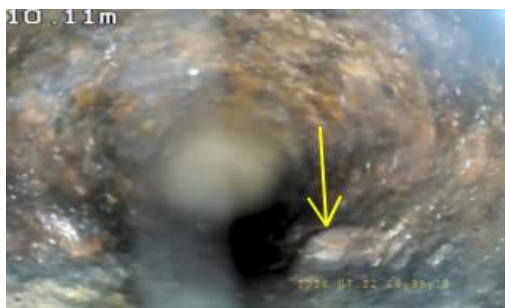
Photo 6-1

Belly's / sags / low spots. This could be caused by pipe settling. Does not appear to be causing any flow issues at this time. However, recommend periodic review.

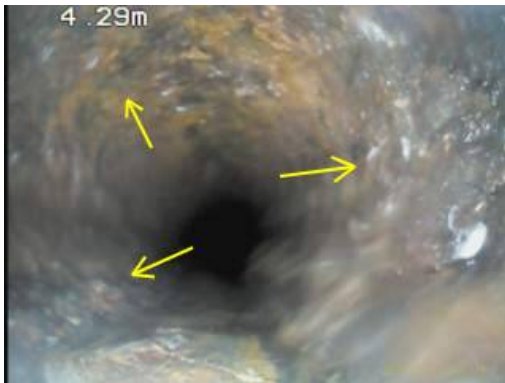
Photo 7-1

7) Rust / scale was visible at the cast iron portion of the main sewer line This could be caused by age and material of pipe. However, recommend periodic review.
