4U Home, Inc

Pool Inspection Report

Property address: **123 Some Street**

Inspection date: **Wednesday, September 9, 2020**

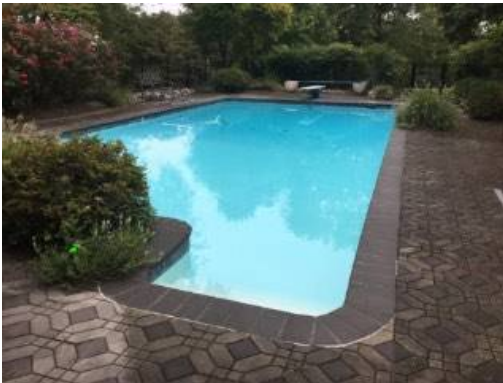
Photo 1-1

1) General pool.

Estimated Length and width of Main Area Pool: 20' x 40'

Maximum depth of pool: 4' x 8'

Water level: Full

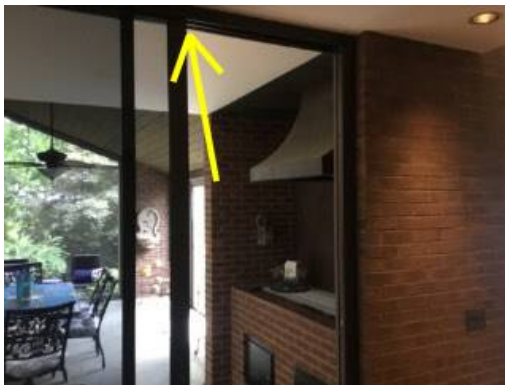
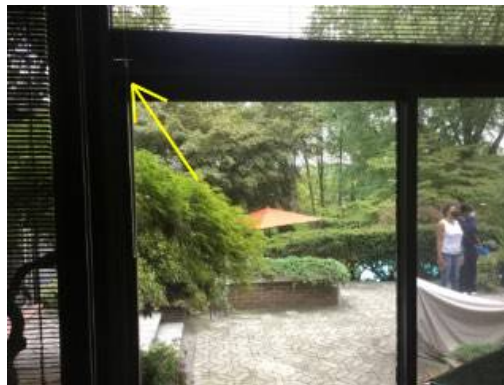
Photo 3-1

- 3) **+** **🔧🔍** The alarm for one or more doors between the house and the was missing. While regulations vary between municipalities, all doors which give access to a swimming pool should be equipped with an audible alarm that should:

- Sound for 30 seconds or more when the door and/or screen are opened
- Sound within seven seconds after the door is opened
- Be loud; at least 85 dBA (decibels) at 10 feet away
- Be distinct from other sounds in the house
- Have a manual switch to disable it temporarily where the switch is located at least 54 inches above the door's threshold
- Have an automatic reset feature

The alarm for one or more doors between the house and the was missing. While regulations vary between municipalities, all doors which give access to a swimming pool should be equipped with an audible alarm that should:

A qualified person should evaluate and repair as necessary. For more information, visit:

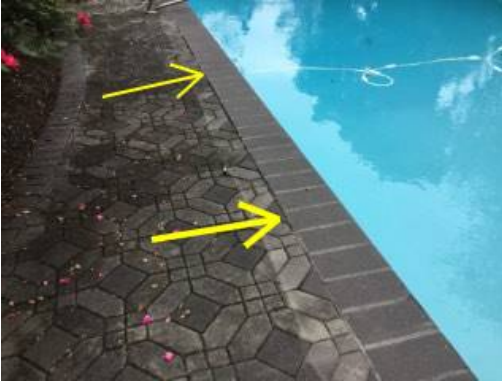
Photo 4-1

One or more trip hazards were found in the decking due to cracks, settlement, heaving and/or deterioration. A qualified contractor should evaluate and repair or replace sections as necessary to eliminate trip hazards.

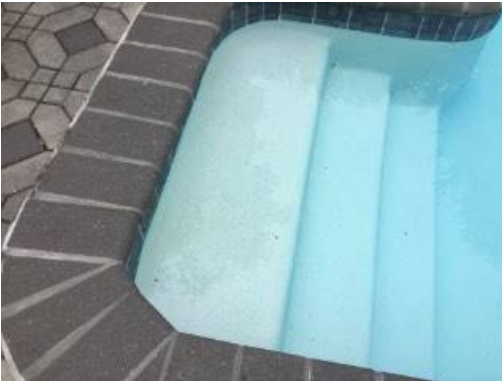
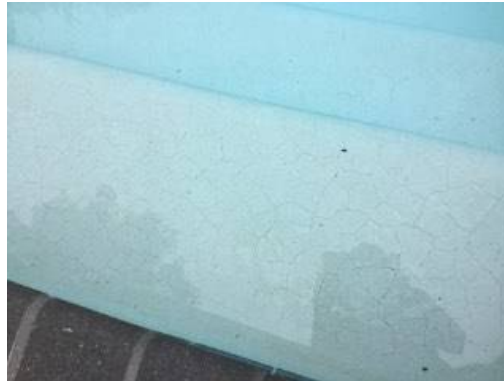
Photo 5-1

The plaster surface of the pool body had significant wear marks in some areas. A qualified person should evaluate and repair as necessary. Concrete pools or spas should be replastered every 10 to 15 years. For more information, visit:

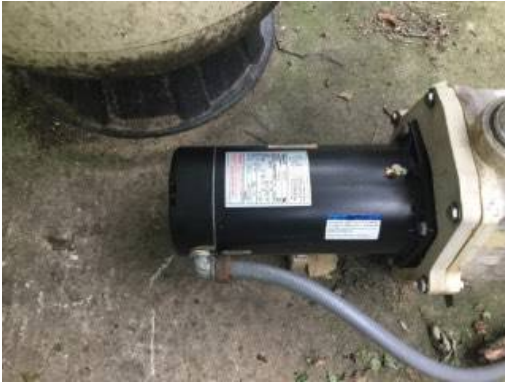
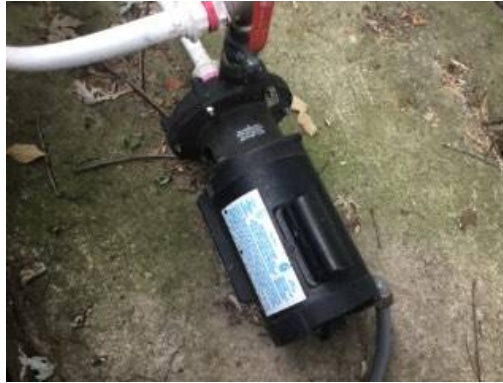
Photo 6-1

6) Photo of ID plate

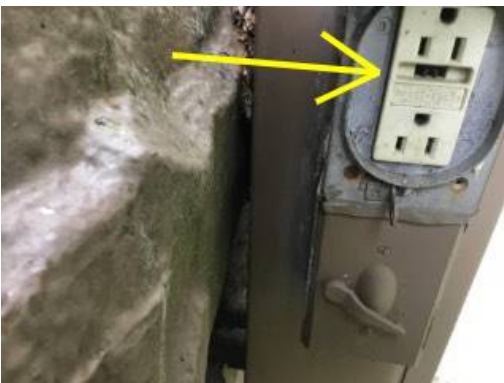
Photo 11-1

One or more ground fault circuit interrupter (GFCI) electric was damaged and wouldn't trip. This is a safety hazard due to the risk of shock. A qualified electrician should evaluate and repair as necessary.

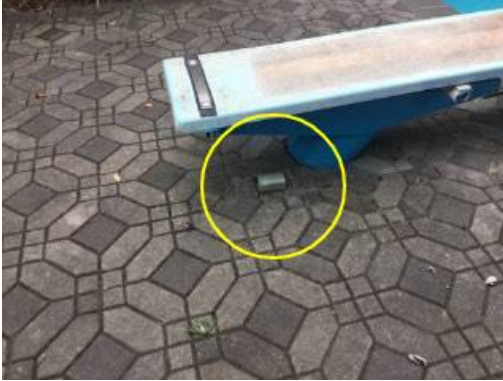
Photo 12-1

The junction box for the pool lighting is too low. Boxes should be a minimum of 12 inches above maximum pool water level to prevent flooding equipment which may be damaged as a result. This is also a potential safety hazard due to the risk of shock. A qualified person should evaluate and make modifications as necessary to eliminate this risk.

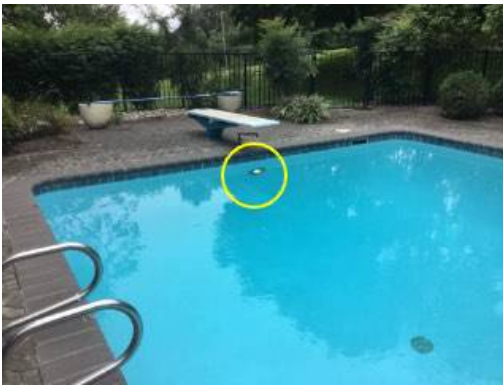
Photo 13-1

Pool underwater light appears that seal is broken and allowing water to pass. Recommend a qualified person replace seal on light.
